Roof Report

Customer: City of Superior	Property: Former Belmont Hotel
Contact: Todd Pryor	Street Address: 271 Main Street
Email: manager@superioraz.gov	City, State, Zip: Superior, AZ 85173
Phone: 520-689-5752	Phone:

A. Roof Inspection Report Summary

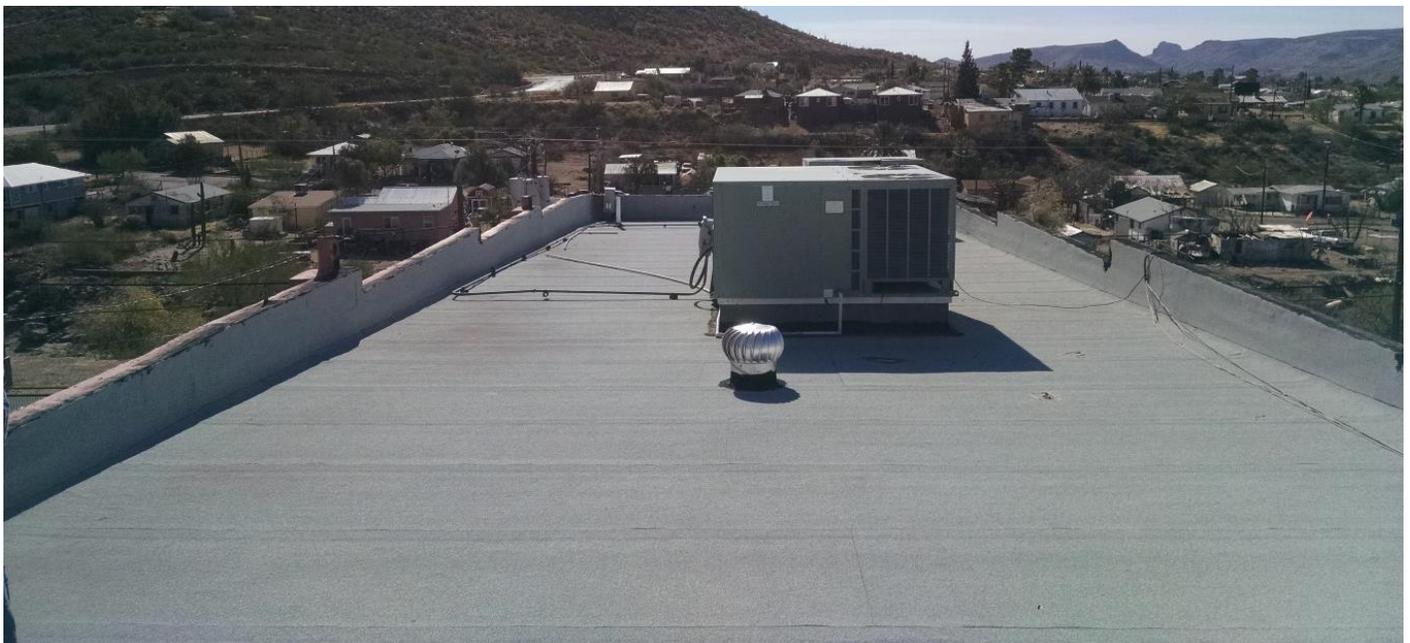
Image 2

Roof deck has good drainage to the rear or south end of building.

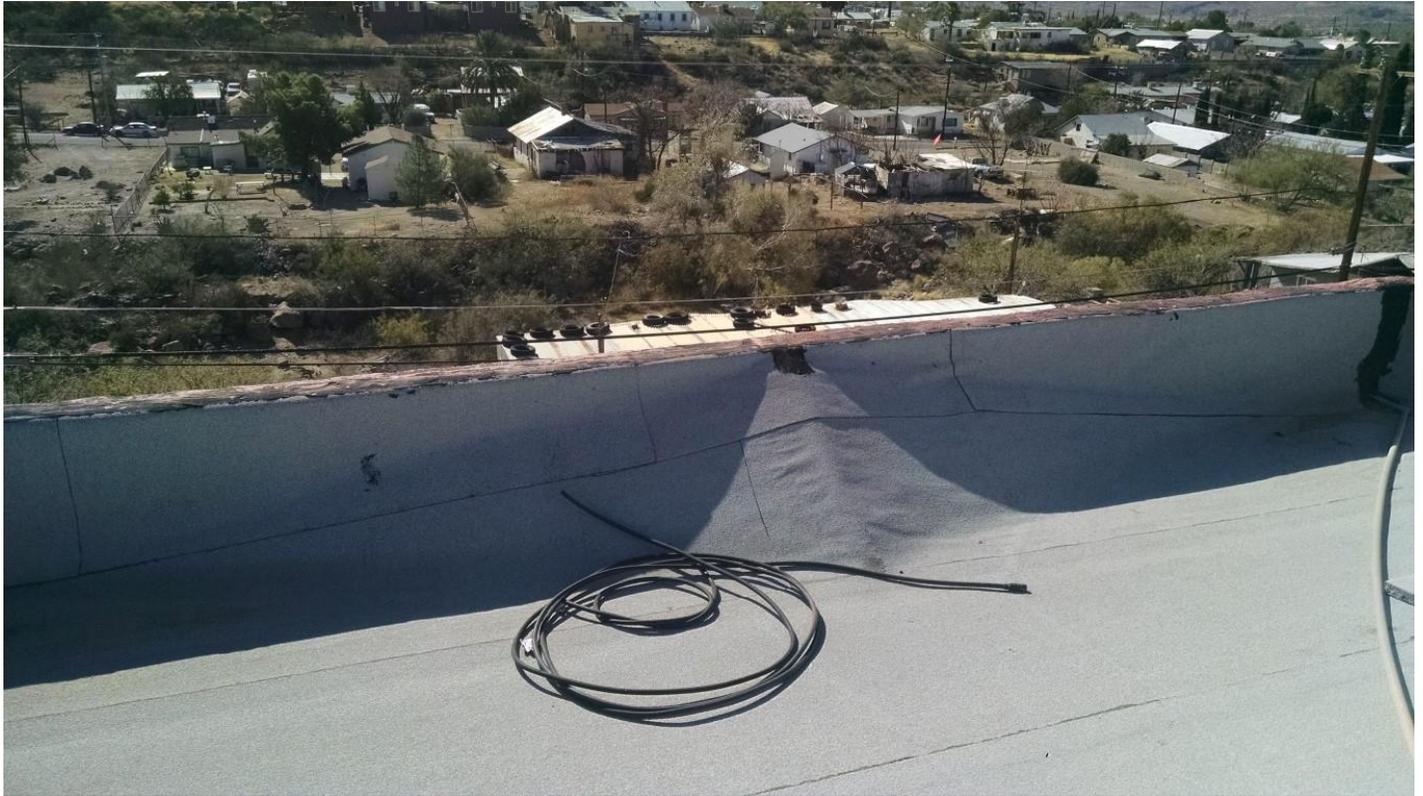
Image 3 Belmont Hotel Superior, Arizona

South wall at rear is equipped with a scupper which helps to divert water out 2 scuppers.
